RESEARCH HIGHLIGHT

June 2008 Technical Series 08-105

# Fixing Houses with High Radon—A Canadian Demonstration

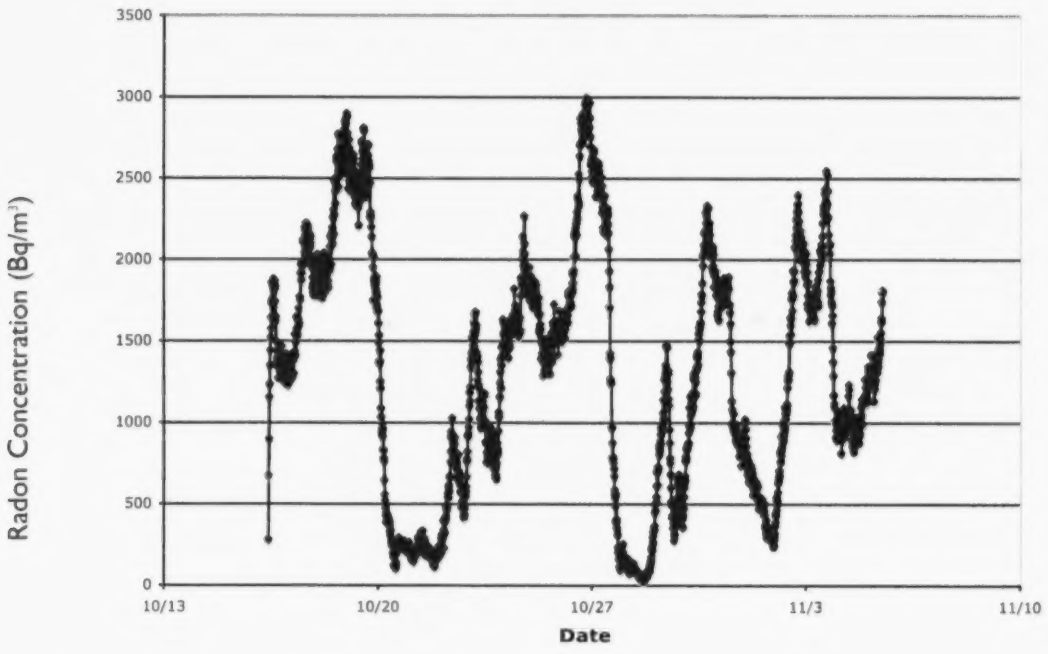
**Figure 1** Continuous radon monitor trace, October–November, 2007

A homeowner in the community of Kanata in western Ottawa contacted CMHC and Health Canada for advice on high radon concentrations he had measured in his new house. Figure 1 shows almost a month of radon readings from his basement. Note that the concentration fluctuates due to house operation, climate factors, and so on. A short reading of two days duration could give a reading as low as 150 Bq/m$^3$ (for example, Oct. 28) or as high as 2,700 Bq/m$^3$ (Oct. 19). For that reason, *Radon: A Guide for Canadian Homeowners* recommends that houses be tested for at least one month.

Averaged over the test period, the homeowner's results were in the order of 1,400 Bq/m$^3$, considerably in excess of either the new or old guideline. The basement had a poured concrete floor and walls, and was not remarkably different from neighbouring houses. It had a slab poured on polyethylene sheeting, which should reduce the radon entry rate.

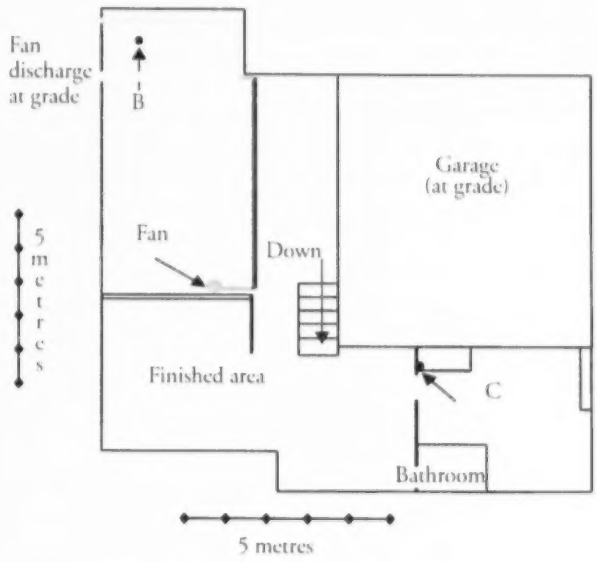
**Figure 2** Installed fan and piping layout

The exhaust fan discharged the sub-slab air at grade and not at roof level, as recommended by the United States Environmental Protection Agency (EPA). This was due to concerns regarding the possible condensation and ice build-up problems within vertical vents on the outside of houses in cold Canadian climates. The project team felt that, if re-ingestion of the exhausted radon through windows, doors or other envelop leakage points in the vicinity of the exhaust fan discharge point was a large factor, the post-mitigation test would show high levels of radon inside the house. The radon concentrations were measured for a month in the winter following installation of the system. Figure 2 shows the basement, the location of the measurement holes (B, C), and the fan and ducting system.

nmissioning of the system, the fan flow was not quite
During the con make a consistent depressurization at the test holes
high enough to in Figure 2. This was cause for some concern, but it
B and C shown run the fan for a month and monitor its effectiveness
was decided to for a way to increase fan flow.
before looking

The consultant drilled several small holes in the floor to measure whether all the air contained in the gravel layer under the slab could be depressurized by an exhaust fan connected through the slab at a single entry point. A ventilation contractor installed the fan and ducting to the consultant's recommendations, and the system was activated.

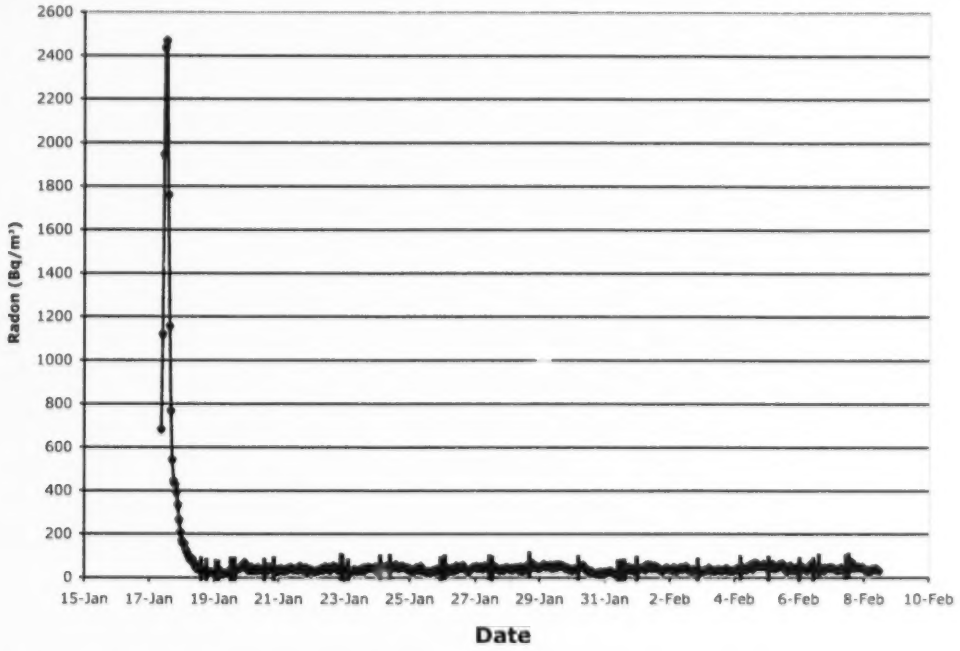
**Figure 3** Cor

remarkably effective (see Figure 3). Radon concentrations
The system was an average of 1,400 Bq/m³ to about 40 Bq/m³ for the
dropped from ng, significantly below the HC 200 Bq/m³ guideline.
month followin r was happy with the installation of the system and
The homeowns. Re-ingestion of the exhausted radon was not a
with the results or in this location during this period.
significant facto
